Docket No. 217 – Development and Management Plan Inspection

Northeast Utilities Service Company Certificate of Environmental Compatibility and Public Need for the construction of a 345-kV electric transmission line and reconstruction of an existing 115-kV electric transmission line between Connecticut Light and Power Company's Plumtree Substation in Bethel, through the towns of Redding, Weston, and Wilton, and to the Norwalk Substation in Norwalk, Connecticut.

Date: March 8 and March 9, 2006

Location: Transition Stations: Hoyts Hill, Archers Lane, Norwalk Junction

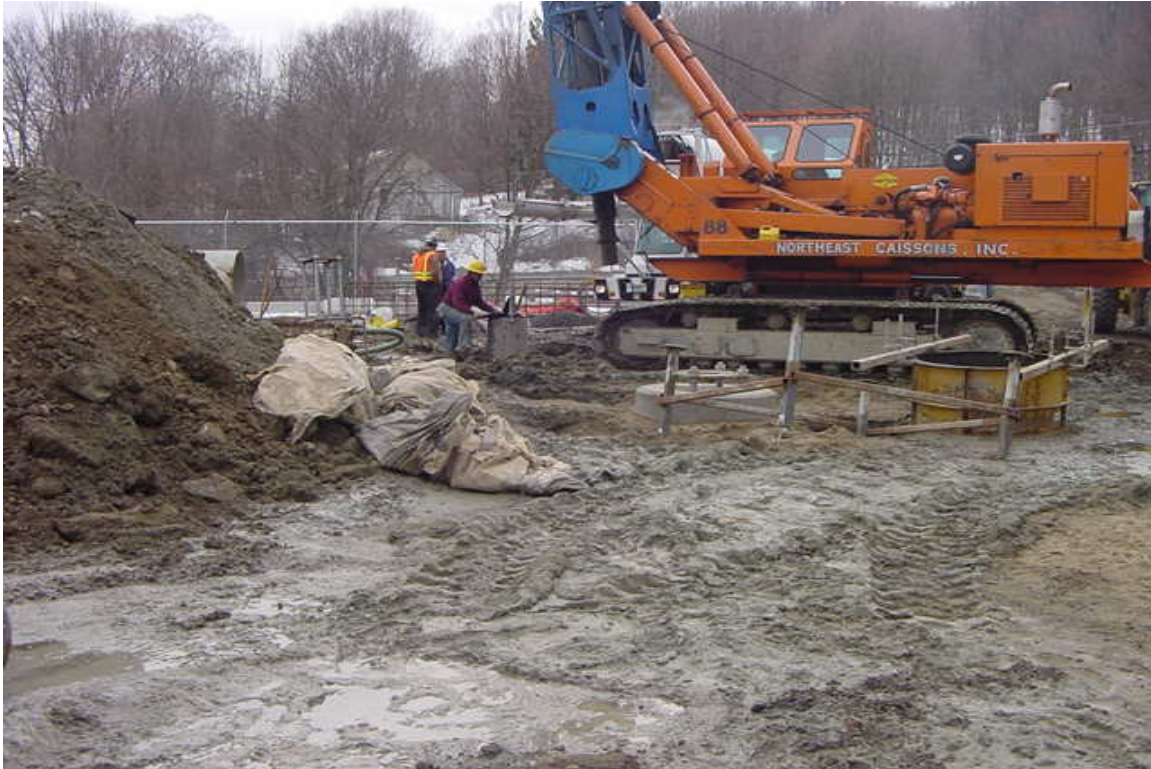
Hoyts Hill Transition Station: Photo shows an overview of the station pad where foundation is being poured for a caisson. 3/9/06

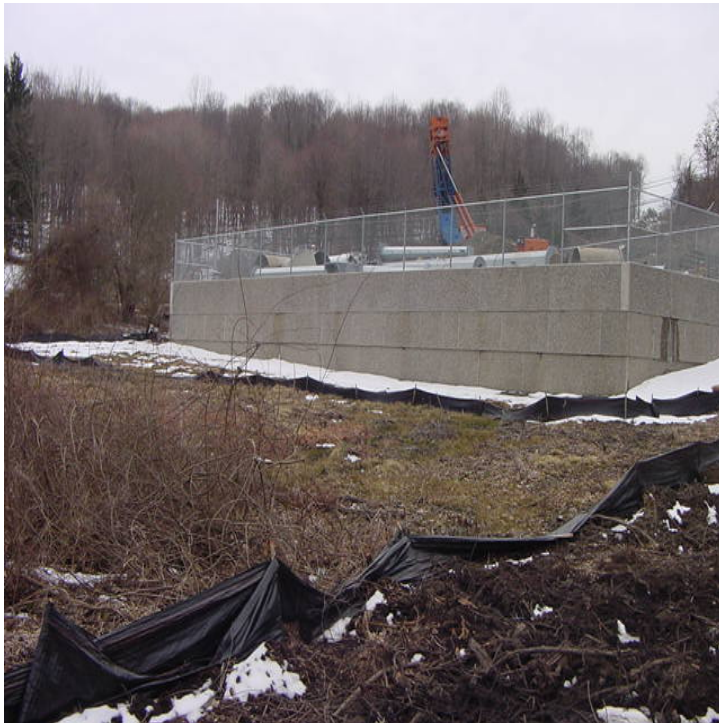
Photo on the left shows a v view of the rear of the transition station. Photo on the right shows the area of silt fence where sediment from gullies and dewatering activities had previously been washing under the silt fence. Some efforts were made to remove some of the sediment. 3/9/06.

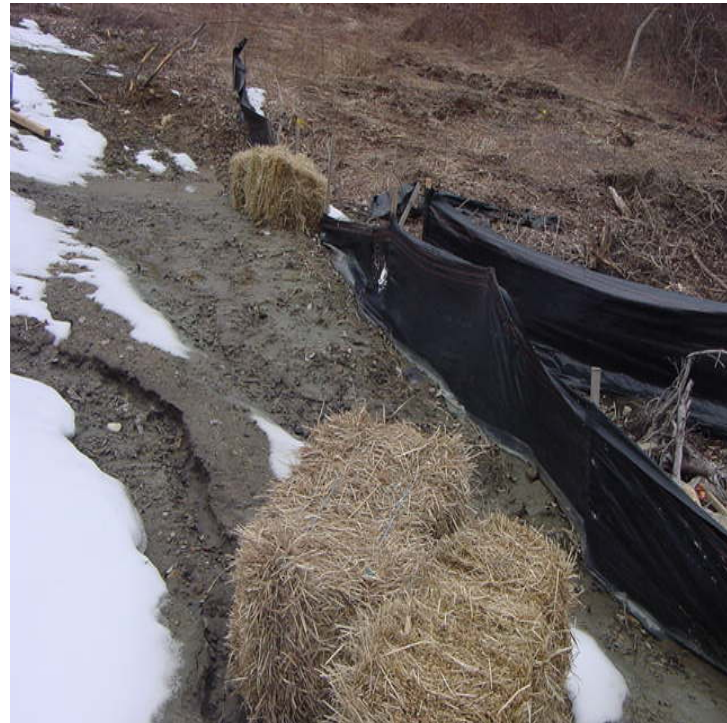
| Areas of Inspection | Observation | Recommended Action | Corrected Actions |
|---|--|---|--|
| Erosion and Sediment Controls (includes inspection within 24 hours of a storm event) | <p>-Hoyts Hill: The perimeter silt fence along the wetlands at the rear of the station is still toed in but portions needs to be re-stapled and patched. 3/9/06.</p> <p>- Sedimentation continued to build through the fence and in the wetland although contractors have made efforts to remove some.</p> | <p>- Repair/restaple the silt fence where necessary. 3/9/06.</p> <p>- Continue to repair or install additional controls in the spot which washed through. 3/9/06</p> <p>- These controls are even more important now that dewatering is occurring.</p> | <p>- Haybales were in place and the fence was re-toed in. Some efforts have been made to remove the sediment. Continue</p> |

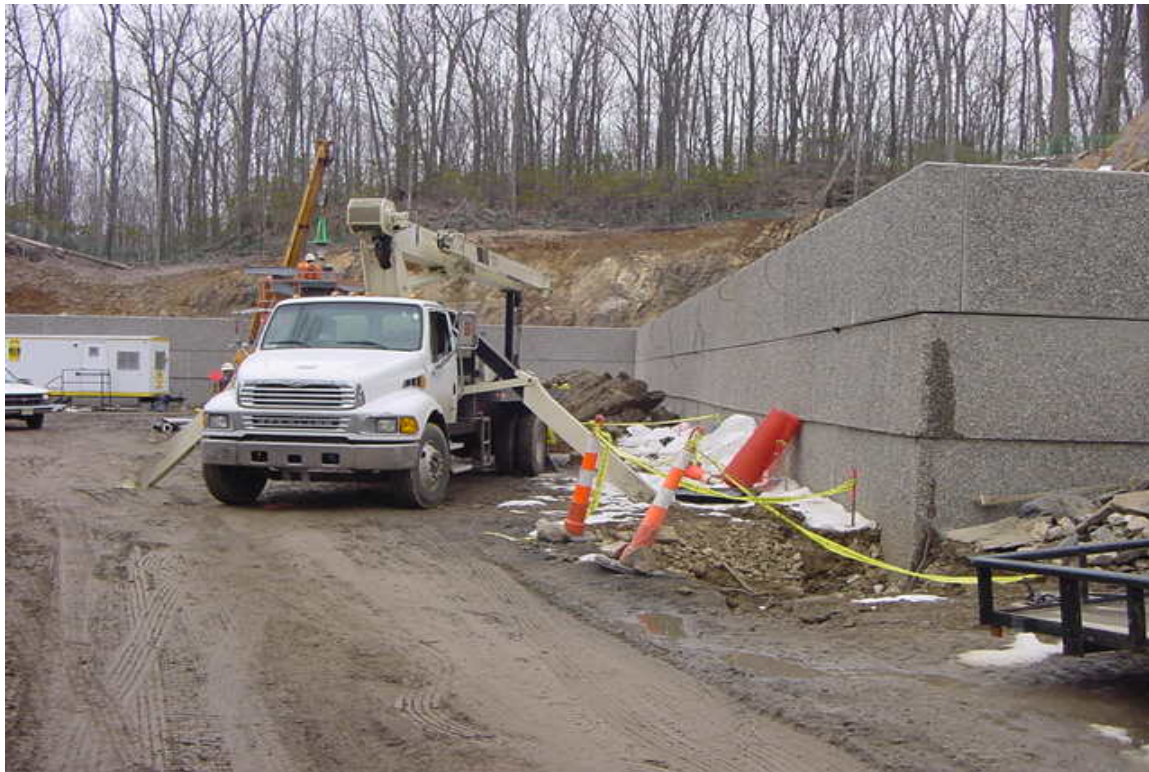
Archers Lane: Photo shows ongoing work on the station pad. 3/9/06.

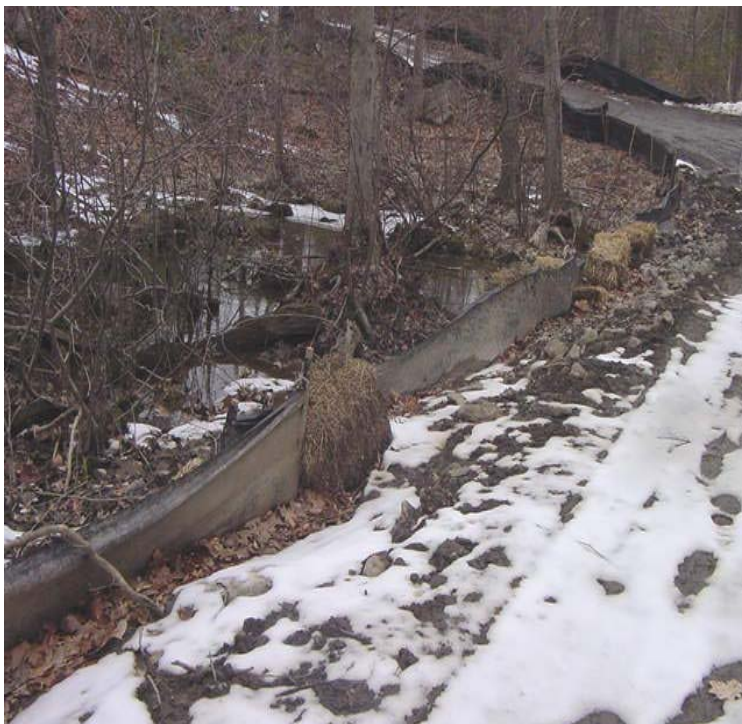
| Areas of Inspection | Observation | Recommended Action | Corrected Actions |
|---|--|--|---|
| | <ul style="list-style-type: none"> - Archers Lane: Controls along the access road to the ROW were somewhat degraded from snow plowing and sedimentation continues in the 1st wetland crossing to varying degrees from a fine layer over the leaf litter to several inches of accumulation. 1/26-3/9/06. -The drainage pipe from the station directs run-off to the stone swale that empties at the silt fence near the 2nd wetland crossing. Haybales are in place in the swale. 3/9/06 -A flowfill stockpile is in place at the top of slope, | <ul style="list-style-type: none"> - Water levels have remained constant for the most part. - Any easily accessible deposits of sediment will need to be removed. Fine layers of silt can remain. 1/26-3/9/06. -Sediment should be removed prior to the growing season. 3/9/06 - Little dewatering has been necessary from the station pad. 3/9/06 -Install erosion controls around this stockpile to | <p>N/A</p> |

Photo on the left is a view of the wetland crossing near the station pad on the access road to the ROW. This area will still need some clean up of accumulated sediment before the growing season. Photo on the right is a view of the backfilled trench along the access drive as part of the 345kV work. Some sediment is building up along the stone wall. 3/09/06

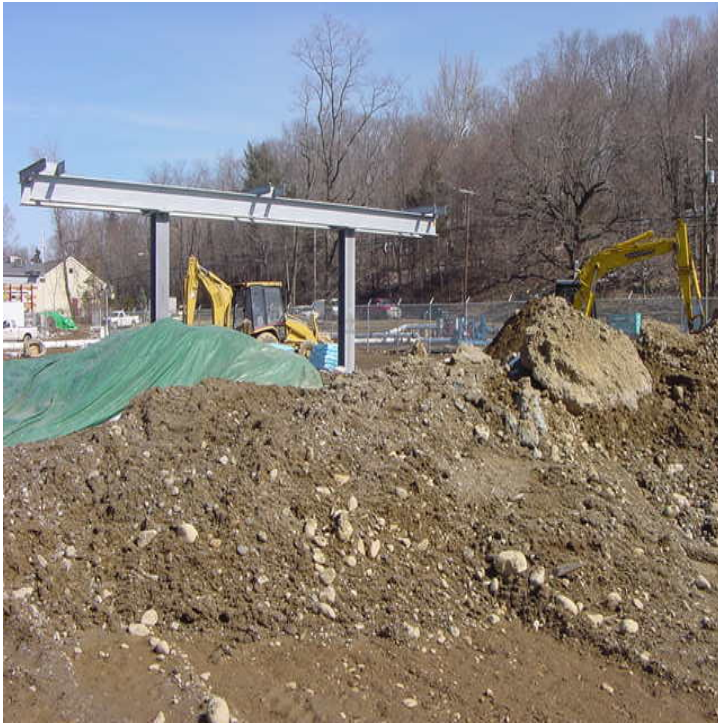
Norwalk Junction: Photo on the left shows the stockpiles stored well within the interior site. Photo on the right shows a view along the rear perimeter of the site. Haybales are working well here. 3/8/06.

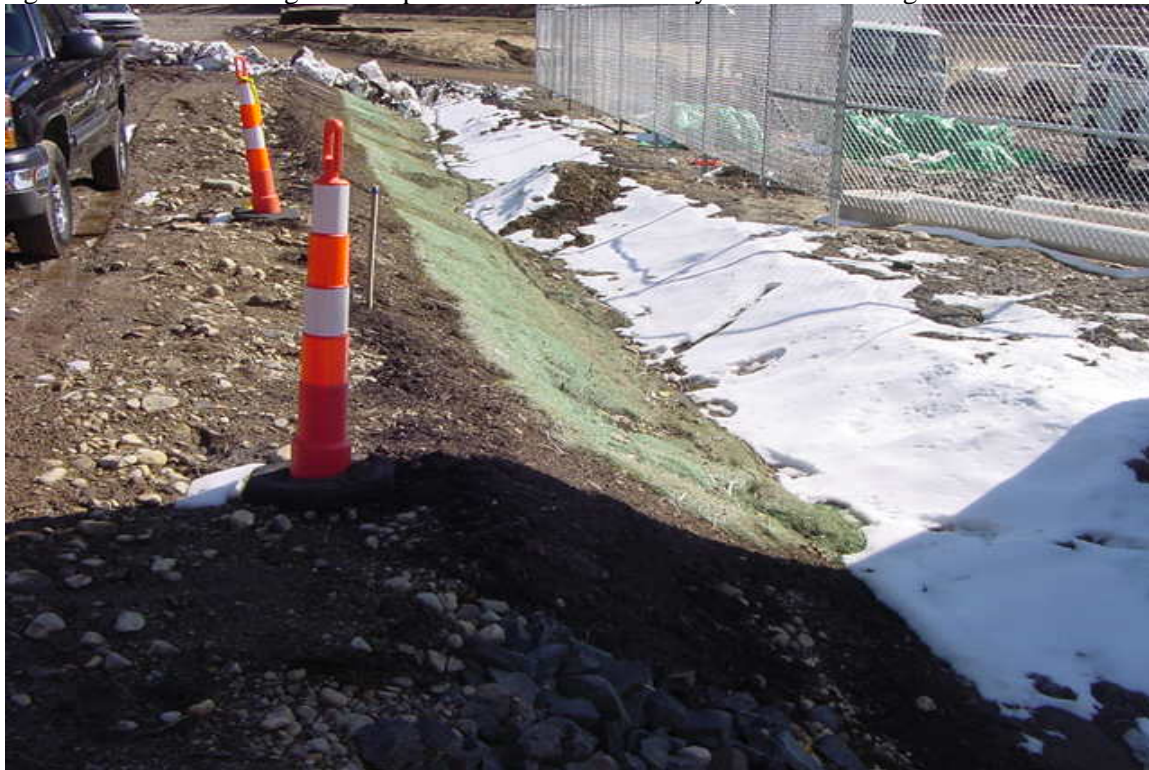
Photo shows sediment remaining from snow piles which were previously plowed into the swales. 3/8/06.

| Areas of Inspection | Observation | Recommended Action | Corrected Actions |
|---|--|--|---|
| Additional Observations | - When snow removal is necessary, place it in areas away from the flow patterns of run-off- i.e. not in swales which can drain to wetlands and carry the sediment. | | |
